Modelling and back-analysing failures in steep limestone cliffs

Magali Frayssines, Didier Hantz

Magali Frayssines, Didier Hantz. Modelling and back-analysing failures in steep limestone cliffs. *International Journal of Rock Mechanics and Mining Sciences*, 2009, 46 (7), pp.1115-1123. 10.1016/j.ijrmms.2009.06.003 . insu-00498736

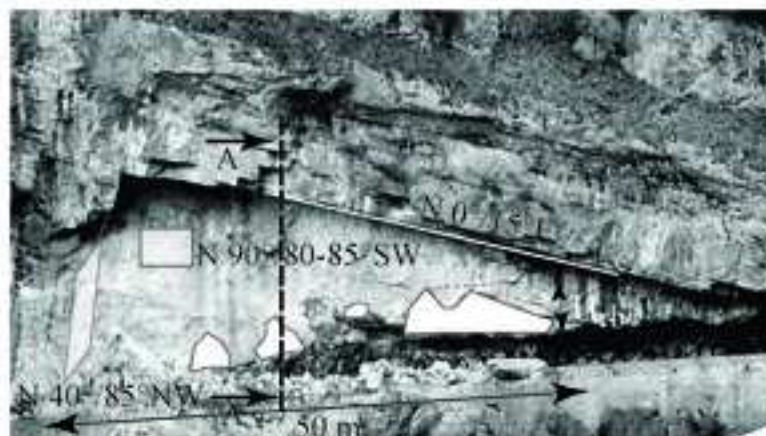
Figure 10

Fig. 10. (A) view of the scar of the Ranc rock fall, with the rock bridges in white and (B) cross-section A-A of the cliff before failure with the position of the equivalent rock bridge. W : weight of the unstable block ; H_{rb} : height of the equivalent rock bridge.

The Ranc rock fall occurred on 30th January, 2004, 50 Km SW of Grenoble (Fig. 2). 2200 m³ of rock collapsed onto the road, killing two people in a car. The cliff is 150 m in height, strikes N80 and dips 85-90° to the South. The fall occurred where the cliff formed an overhang due to the construction of the road 150 years ago (Fig. 10B). The limestone beds strike N0°, dip 15° to the East, and they are cut perpendicularly by 2 joint sets N100°/90° (J1) and N33°/75°SE (J2). The scar is 50 m wide, about 20 m high and the mean thickness of the fallen mass was approximately 2.5 m. The failure surface is made up of a bedding plane N0°/15°E and two planes, N90°/80-85°S and N40°/85°NW belonging respectively to the joint sets (J1) and (J2) (Fig. 10A). In the major part of the scar, the rock is coated by a calcite crust (yellowish-orange colour). Intact rock fracture surfaces have been observed in the lower part of the plane N90°/80-85°S (Fig. 10). These fresh fracture surfaces, which cover an estimated area of 52 m² (5% of the whole scar area), are due to the failure of rock bridges. The equivalent rock bridge considered in the analysis has a height of 3.5 m and a width of 35 m. We obtained tensile strength and cohesion values equal to 3.2 MPa and 10.5 MPa respectively.
